# Manhole Inspection Summary

Manhole # S25I\_\_051MH

Insp Date: **3/13/08 2:39 PM**

**Location** Address: **Lemmon St**

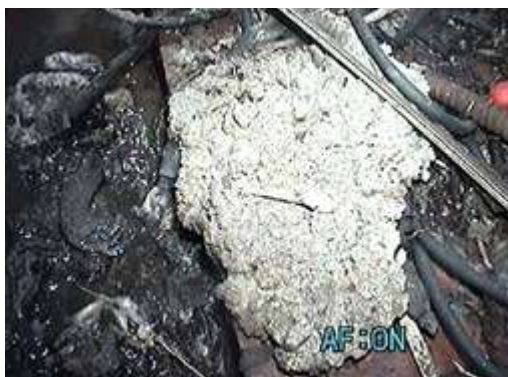
Defect 6

Condition: ☒ Sound ☐ Cracked ☐ Root Intrusion ☐ Deteriorated ☐ Leaks ☐ Debris

debris on bench

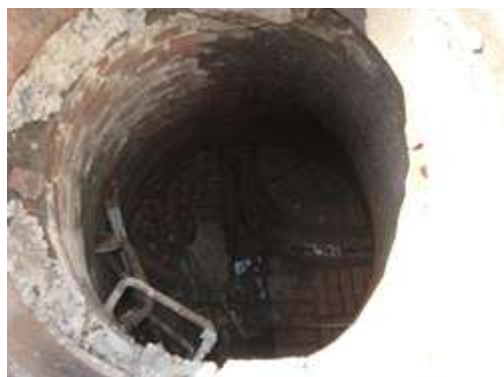
Defect 2

**Frame** Offset: **2** (in.) Condition: ☒ Sound ☐ Cracked ☐ Leaks

frame offset

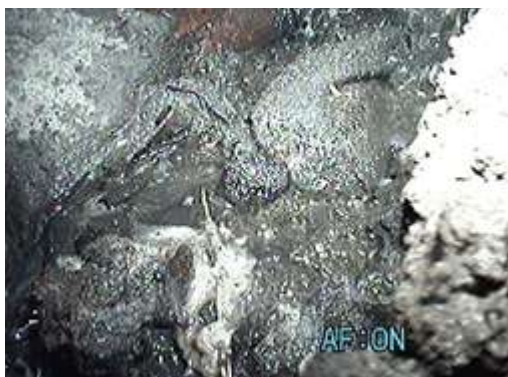
Defect 3

Condition: ☐ Sound ☐ Cracked ☐ Root Intrusion ☐ Deteriorated ☐ Leaks ☒ **Debris**

debris in channel

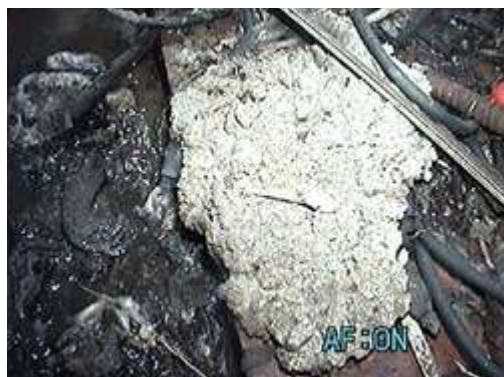
Defect 3

debris on bench

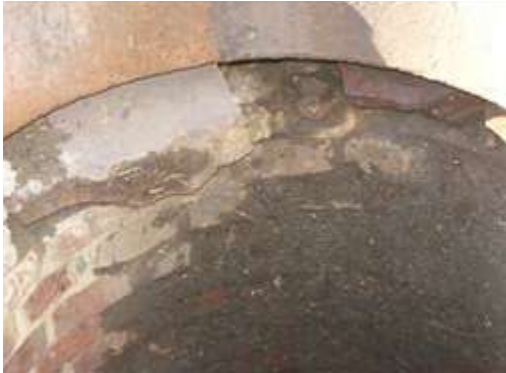
Defect 4

Condition: ☐ Sound ☒ **Cracked** ☐ Root Intrusion ☒ **Loose Brick** ☒ **Deteriorated**

Infiltration: ☐ None ☐ Joint ☐ Cracks ☐ Mortar ☐ Roots ☒ **Wall**

chimney infiltration/loose bricks

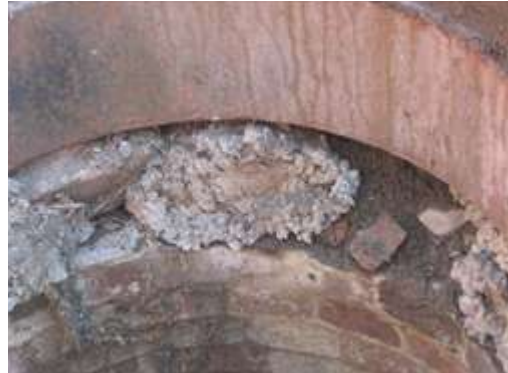
Defect 1

Chimney missing bricks loose mortar

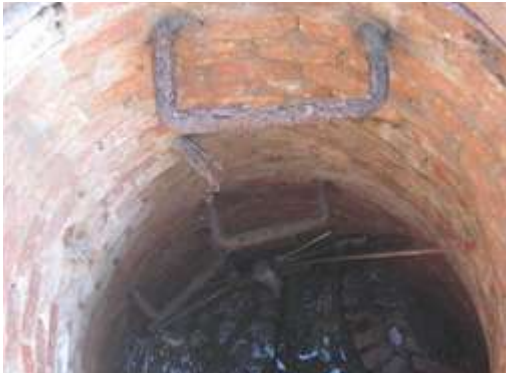
**Steps** Count: **4** Missing: **1** ☒ **Corroded**

corroded steps & missing steps

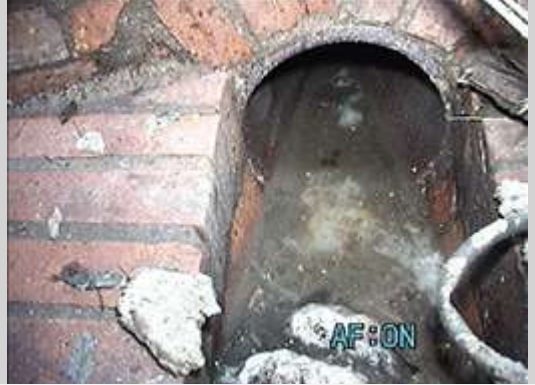
6 O'Clock Inflow

Deposits: ☐ None ☐ Mud ☐ Sludge ☒ **Debris** ☐ Grease

Silt Depth: **3** (in.) Deposits Extent: **Heavy**
